City Hall

Supplemental Condition Assessment

FINAL REPORT – REVISION 1

April 1, 2021
WJE No. 2021.1687

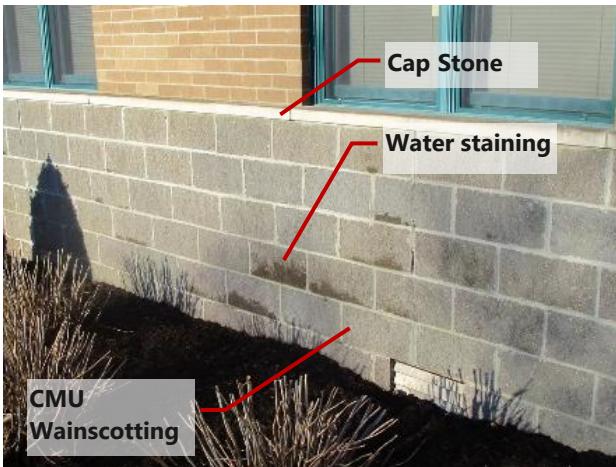
- Water staining was observed at localized areas of the split face CMU wainscot throughout all exterior walls of the building (Figure 6). More severe water staining was observed at the partial walls near the two north entrances and portico column bases on the south end of the building (Figure 7 and Figure 8).
- EIFS lamina was cracked at both corners of the semi-circular window within the north portico (Figure 9).
- EIFS lamina was punctured in several locations on the chimney stack (Figure 10).
- The coating on portico columns was cracked and peeling. At isolated locations, corrosion staining is visible through cracked coating (Figure 11 and Figure 12).
- One window frame on the north facade was painted black (Figure 13).

Water staining on CMU likely resulted from expected drainage of water in the exterior wall. The original architectural drawings¹ schematically show the exterior wall designed as a cavity wall system with an air cavity between the masonry veneer and the wood-framed backup wall. Cavity walls are designed to manage water within this drainage cavity. Small amounts of water are expected to enter the cavity wall system through the mortar joints and even the masonry veneer itself. The water which enters the wall is collected in the drainage cavity which directs water to through-wall flashings to drain to the exterior.

Also, water absorbed into porous masonry veneers, such as the split face CMU wainscot, may weep out of mortar joints after a rain event. Fishers reported no water infiltration at exterior walls; thus, the water staining is likely only an aesthetic issue at this time. However, over time, continued excess water absorption through the CMU walls may lead to freeze-thaw damage to the CMU. WJE observed this at localized areas of the CMU walls in 2018 at the north entrance ramps, which remain. If concerns remain, further monitoring and investigation of the exterior walls, such as water testing and material testing, may provide further information on the performance of the exterior walls.

Figure 6. Water staining on split face CMU wainscoting

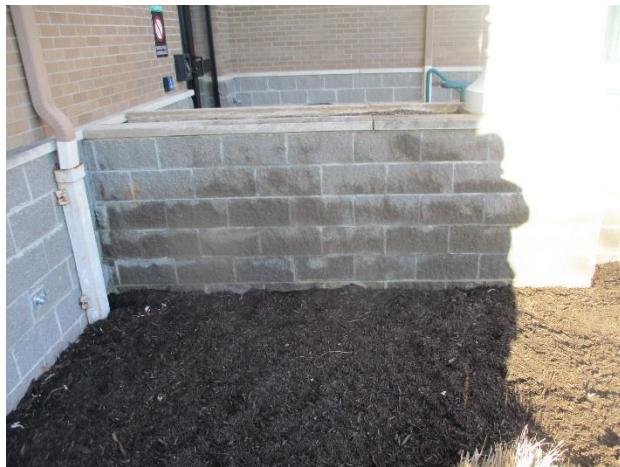
Figure 7. Water staining on the CMU partial wall near the northeast entrance

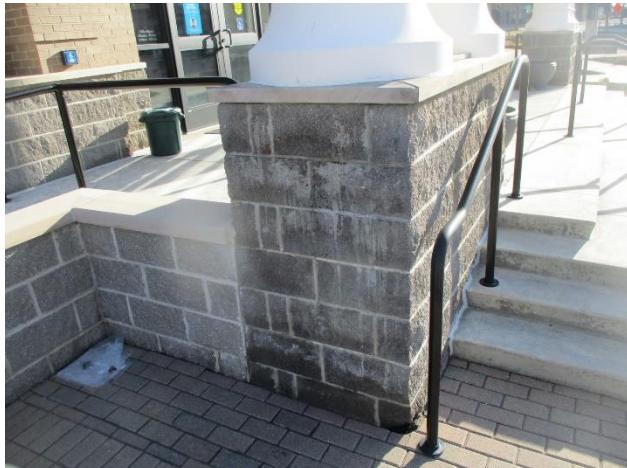
Figure 8. Water staining at the portico column base near the south entrance of the building

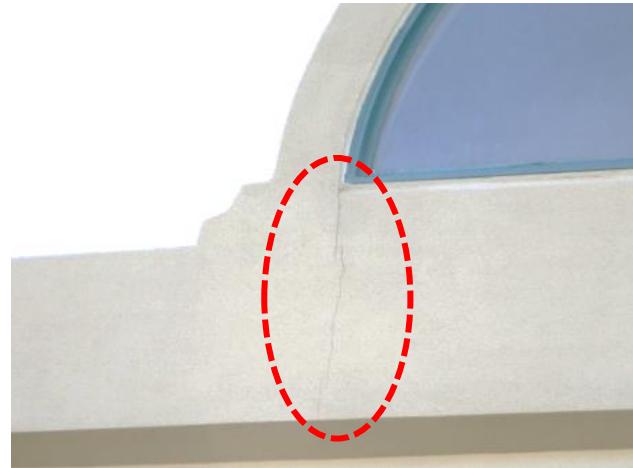
Cracked and punctured EIFS lamina can lead to water infiltration into the EIFS insulation and subsequent water damage to the wood structure and interior finishes. The observed EIFS damage is localized and not widespread, thus the damage is likely related to isolated exposure or impact and can be treated with topical repairs. However, further investigation of the EIFS damage would be necessary to confirm the cause or define any underlying damage.

Figure 9. Crack in EIFS lamina at north portico window

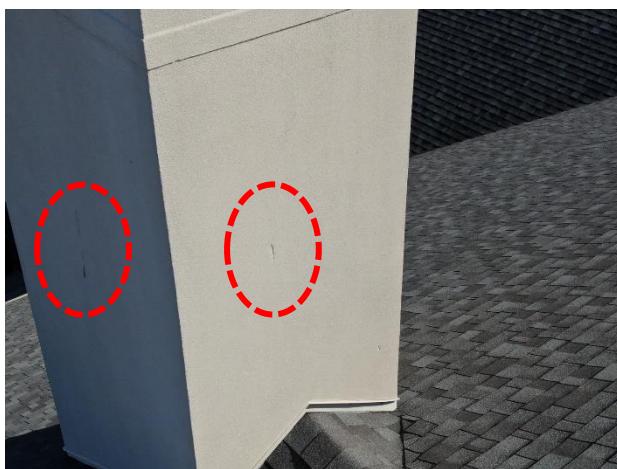
Figure 10. Punctured EIFS lamina at the chimney

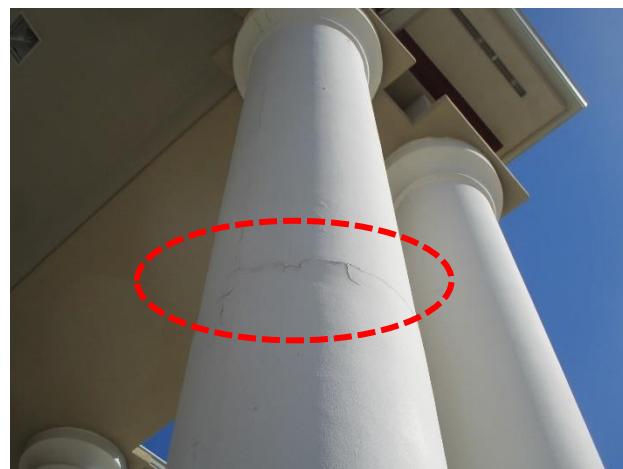
Failed coating on portico columns may continue to cause corrosion of metal within the column sleeves. The original drawings² indicate the visible portions of the portico columns are only decorative fiberglass elements covering steel HSS columns which support the portico above. There are no metal elements shown in the original drawings within the column sleeve material, thus further investigation would be warranted to determine if the corrosion staining is indicative of a more significant issue.

Figure 11. Cracked coating at portico column near the south entrance

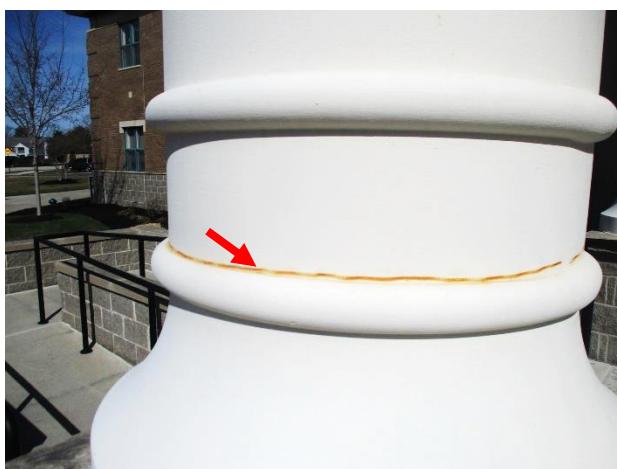
Figure 12. Corrosion staining at the base of the portico column near the south entrance

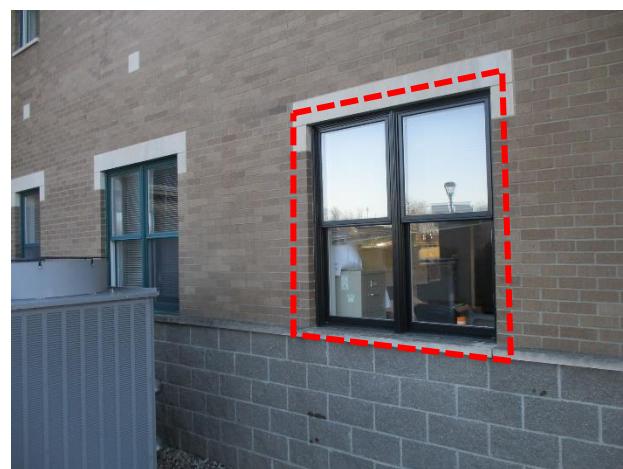
Figure 13. Painted window frame on the south facade

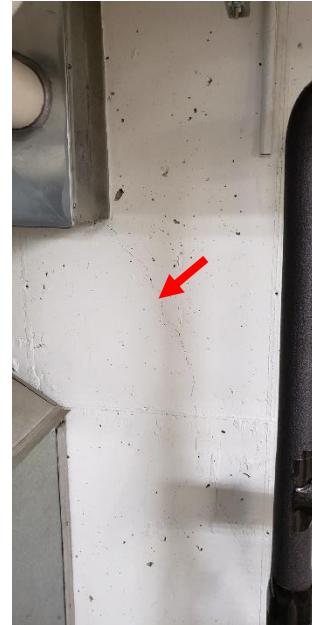
- Along the east wall of the basement, a steel wide-flange beam ("I-beam") was raised 0.3 inches above the bearing surface of the pocket (Figure 14).
- Hairline, vertical cracking existed on the west wall of the concrete basement near a wall penetration for a mechanical duct (Figure 15).

Figure 15. Hairline, vertical cracking on west wall of concrete basement

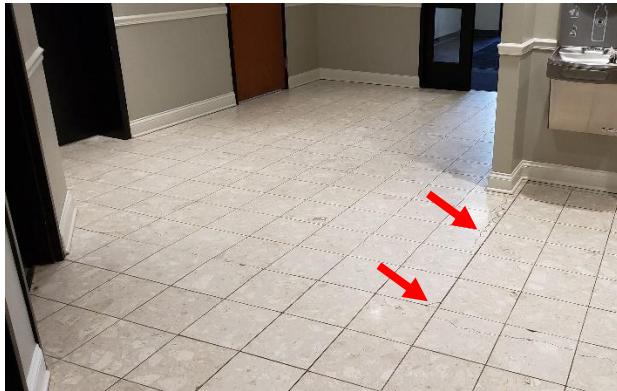
- In general, observed distress was primarily limited to the western half of the building.
- Floor tile damage, comprised cracked tile and vertical offsets, existed on the first floor concrete slab-on-ground around the elevator (towards the west end of the building) and in the adjacent janitor's closet (Figure 16 and Figure 17).

Figure 16. Cracking of floor tile at first floor around elevator and near janitor's closet

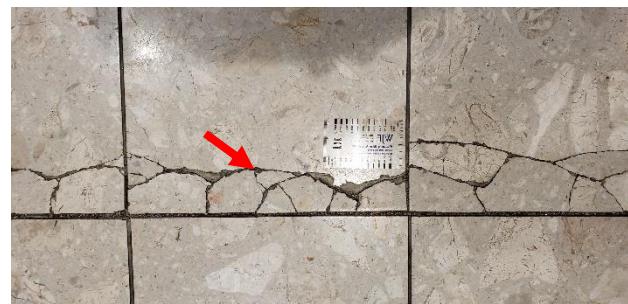
Figure 17. Cracking of floor tile at first floor around elevator and near janitor's closet

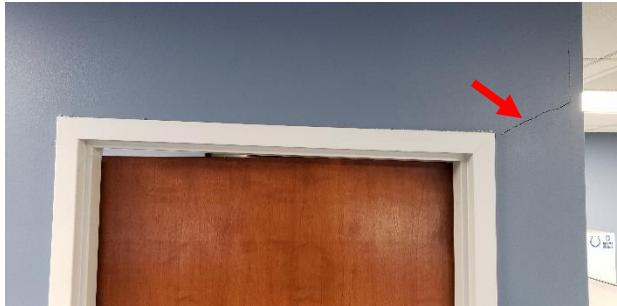
- Cracks in walls at the first floor typically widen with increasing height. The widths of the cracks vary from hairline to 1/4 inches (Figure 18). The widths and orientations of the cracks are consistent with the southwest corner of the building moving differentially relative to the areas south of the elevator adjacent to the basement at the northwest corner of the building.

Figure 18. Crack in wall widened at increasing height

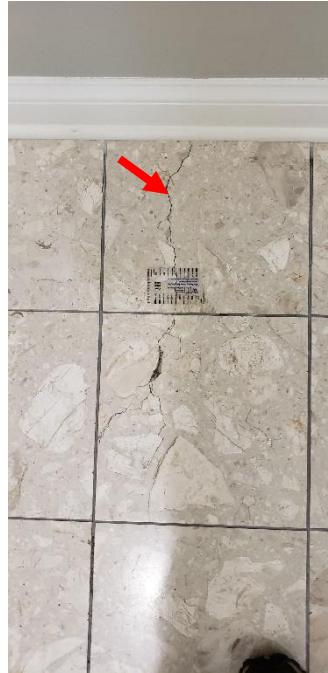
- Cracked floor tiles existed below the landing of the main stairway (Figure 19).
- Cracking existed along the edges of the coffered ceiling in the Auditorium, where the gables meet the flat upper section (Figure 20).

Figure 19. Cracks in floor tiles below landing of main stairway

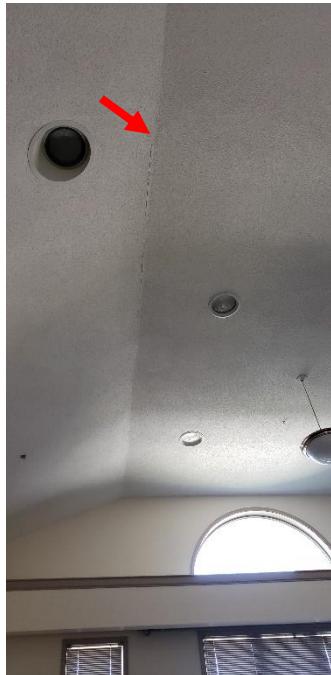
Figure 20. Cracks in gypsum sheathing of Auditorium

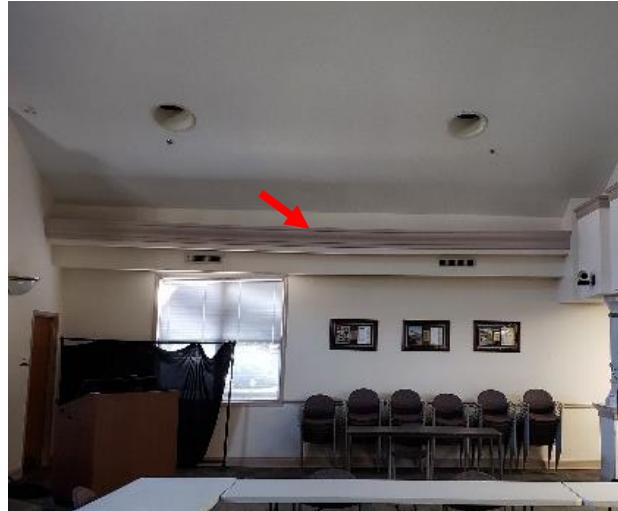
- The wallboard around the duct along the east wall of the Auditorium had pronounced sagging and narrow cracking (Figure 21)
- The coffered ceiling edge of the Auditorium against the top of the wall appeared to have a minor visible downward displacement away from its north and south ends.

Figure 21. Sagging of duct on east wall of Auditorium

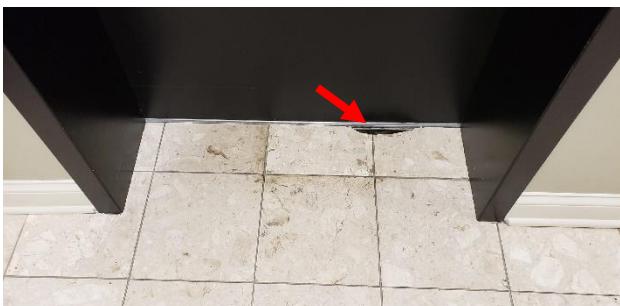
- Cracked floor tile existed in front of the elevator at the second floor (Figure 24). A large section of a floor tile was missing the elevator door threshold at this location
- On the wall north of the elevator core at the second floor, a vertical gap existed between the bottom of the wall and the floor. The wall was tight against the ceiling. Fishers reported this particular ceiling crack was repaired less than a year before our assessment.

Figure 24. Cracked floor tile in front of elevator at the second floor

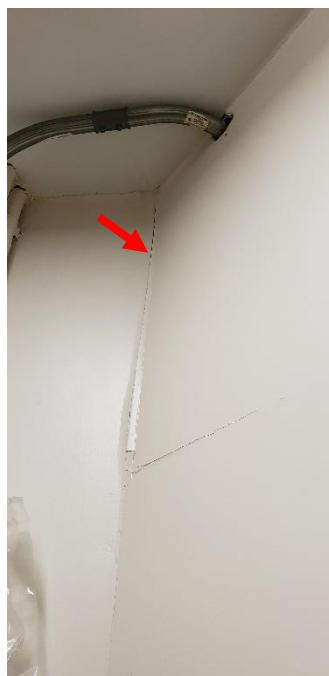
- The gypsum sheathing on the northeast wall of the second floor janitor's closet was buckling at horizontal wallboard joints (Figure 25).
- Replacement tiling was observed in the northernmost toilet stall of the second floor men's restroom. The floor had pronounced downward slope toward the southwest building corner; the slope was readily visible based on comparison to the toilet that appeared level.

Figure 25. Cracked gypsum sheathing at second floor janitor's closet

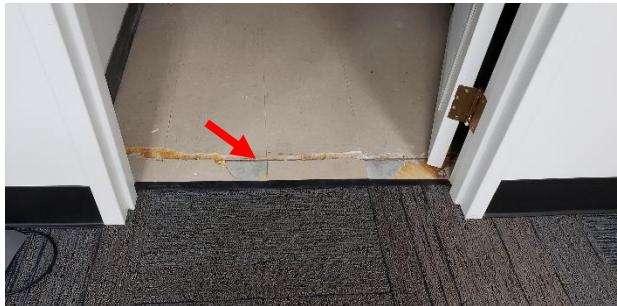
- Extensive floor cracking with 3/8-inch gap was evident along the door threshold between the conference room and adjoining server room on the second floor. While standing in the doorway and looking at the floor, light from the room below was visible, and a vertical leg of a plate or angle was visible along the crack edge (Figure 26).

Figure 26. Cracked floor tiles at door threshold to the server room at the second floor

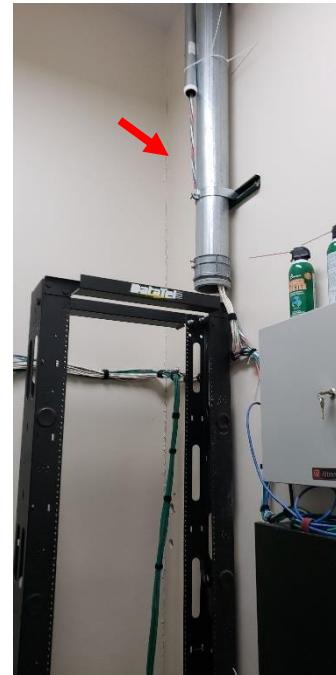
- At the northeast corner of the server room, a vertical wall crack was noted where the north wall meets the east wall. The tearing and stretching at the crack indicated the east wall is down relative to the north wall. The crack was widest in the top half of the tall wall, where its width was approximately 3/16 of an inch (Figure 27).

Figure 27. Crack in gypsum sheathing at northeast corner of server room on second floor

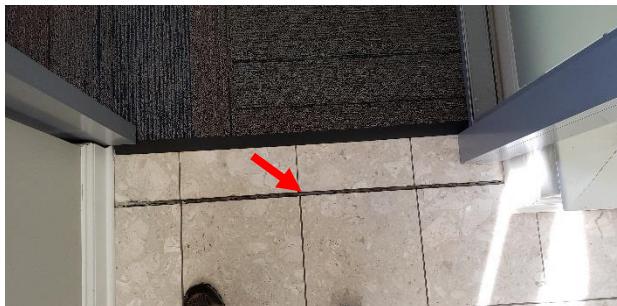
- The joints of the upper-level floor tiles around the main stair opening have substantial cracking in both north-south and east-west directions (Figure 28). Separations also existed in wood trim at the stair opening at mitered corners (Figure 29).

Figure 28. Cracking in joints of floor tiles adjacent to main stair opening on second floor

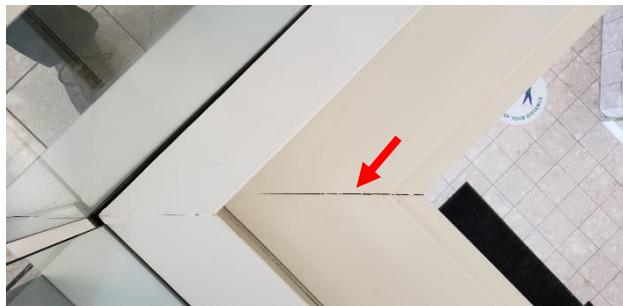
Figure 29. Separations in wood trim at mitered corners adjacent to main stair opening on the second floor

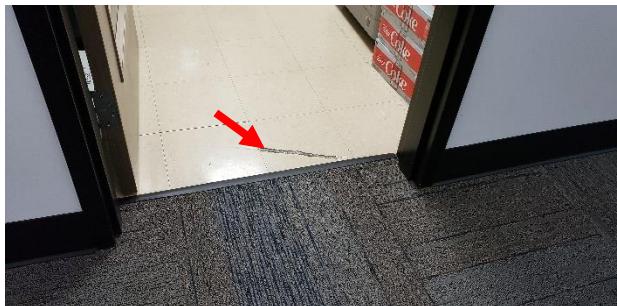
- A cracked floor tile existed in the kitchenette in the Administration offices at the east end of the building (Figure 30).
- Horizontal cracking of interior gypsum sheathing and nail pop-outs existed in the storage room at the north end of the building adjacent to the stairwell on the second floor.

Figure 30. Cracked tile in administration office kitchenette

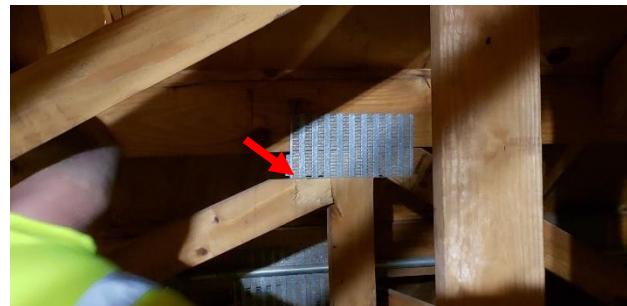
- Previously repaired roof trusses existed in the west attic space. The repairs consisted of truss member replacement or sistering (adding framing along existing framing).
- Diagonal web members of several trusses were pulled away from the metal plates that originally connected the web members to the cord members (Figure 31). This condition was primarily along the west face of the building, near mid length of the building.
- Plywood on the wall between the attic space and mechanical space had noticeable buckling.

Figure 31. Disconnected diagonal web member of truss in west end of attic

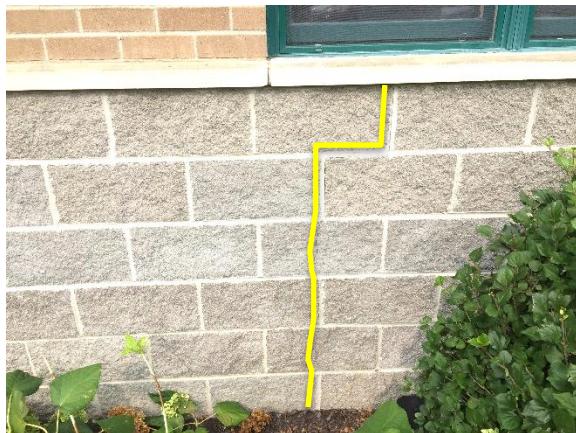
Figure 8. Vertical and stair-stepped cracks in the CMU (shown in yellow)

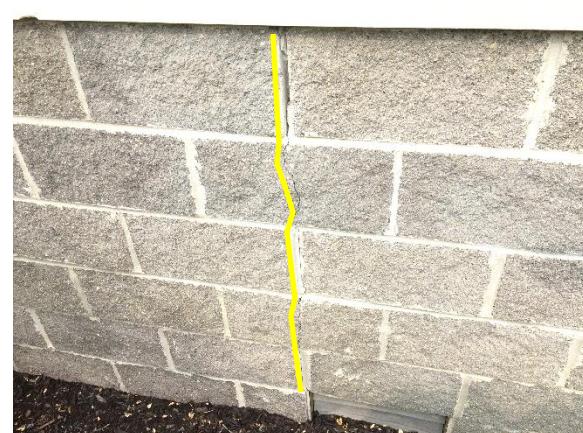
Figure 9. Vertical crack in CMU (shown in yellow)

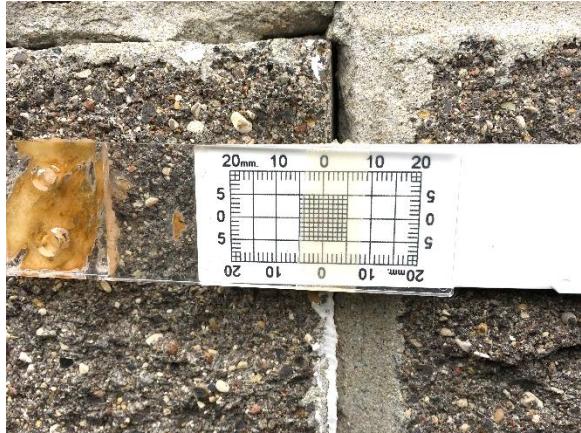
Figure 10. Existing crack monitor on the west wall

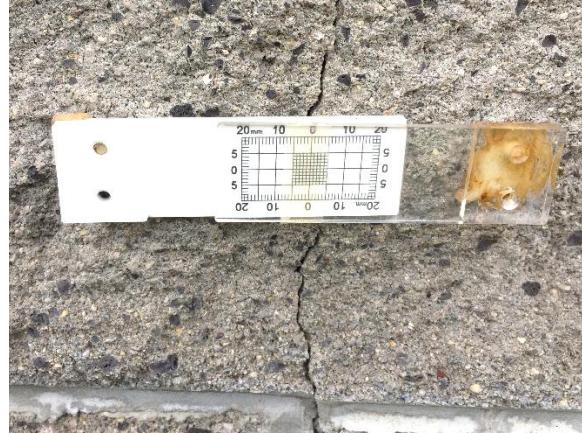
Figure 11. Existing crack monitor on west exterior wall

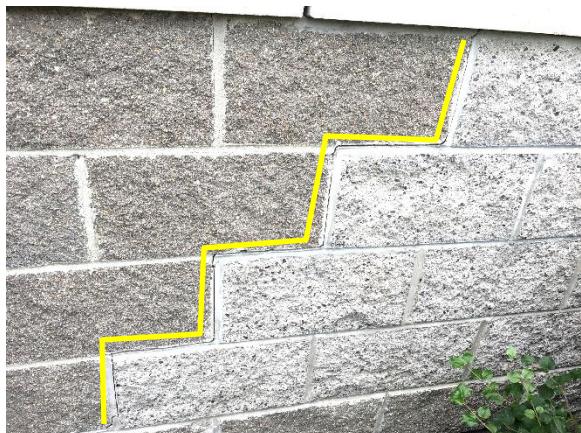
Figure 12. Stair-stepped crack in CMU (shown in yellow)

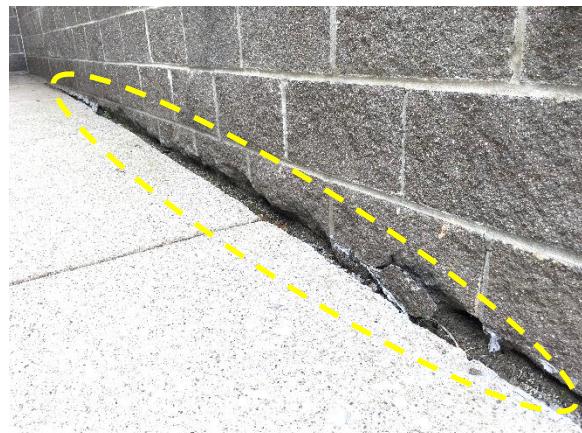
Figure 13. Spalled and cracked CMU along the joint between the wall and concrete ramp

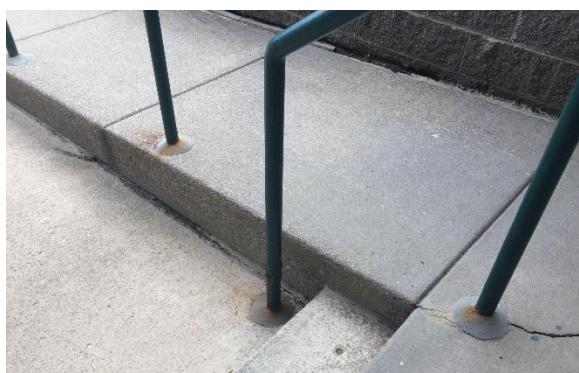
Figure 14. Corrosion and staining at the base of the handrails on the north side of building

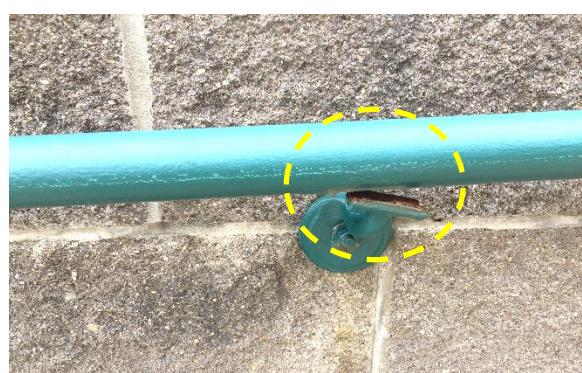
Figure 15. Broken handrail connection

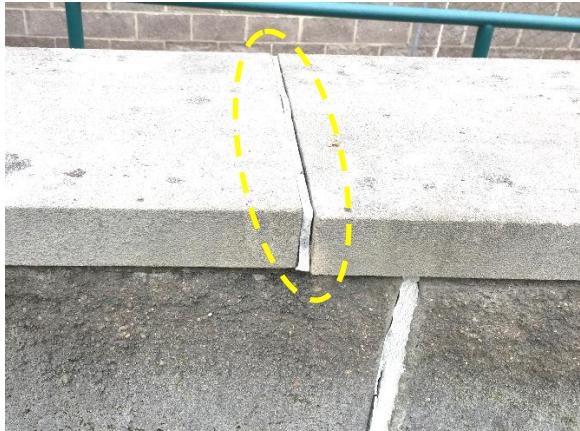
Figure 16. Failed sealant head joint between limestone copings

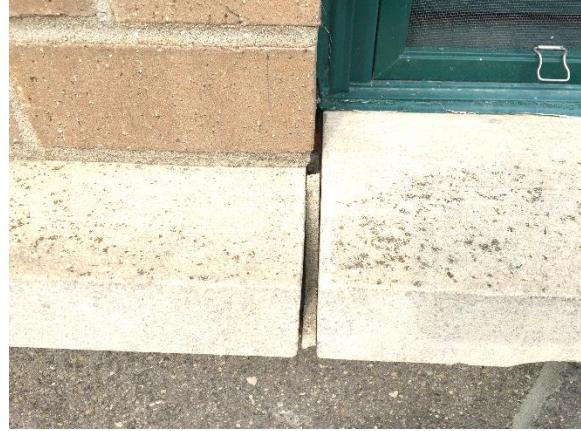
Figure 17. Cracked and missing mortar at a head joint between limestone accents

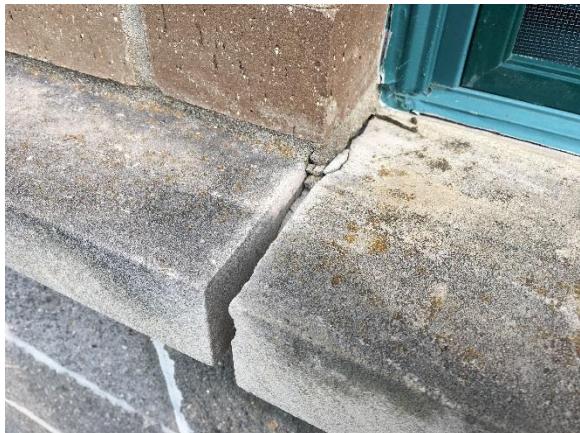
Figure 18. Missing mortar at head joint between limestone accents

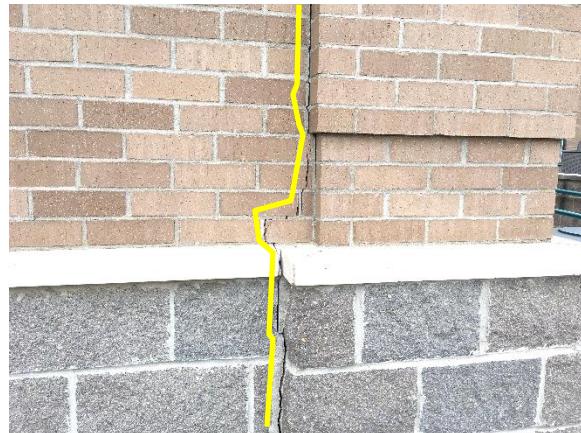
Figure 19. Cracked mortar joint near corner on the north wall (shown in yellow)

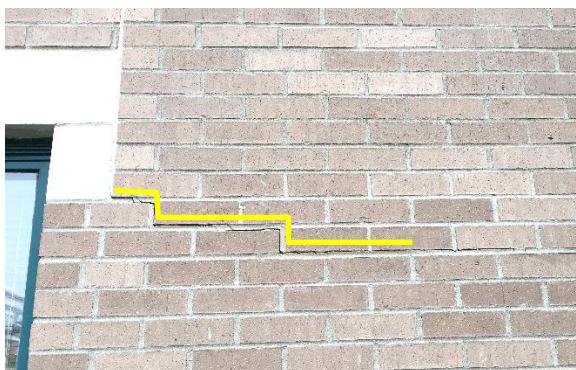
Figure 20. Cracked mortar joint (shown in yellow)

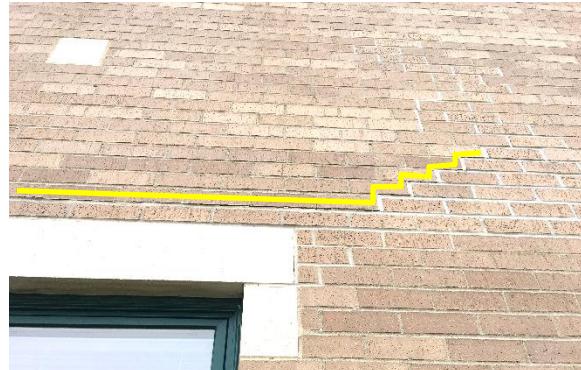
Figure 21. Cracked mortar joint (shown in yellow)

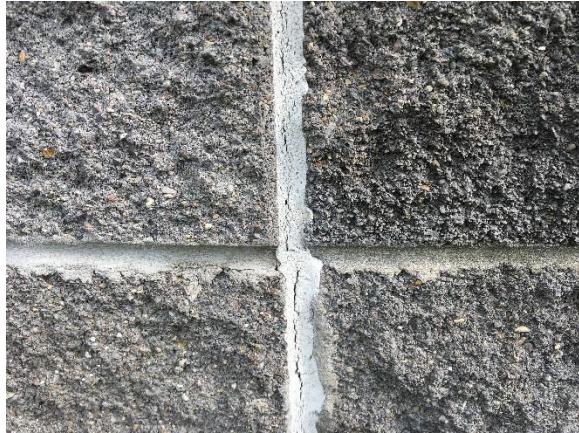
Figure 22. Crazing sealant at expansion joint

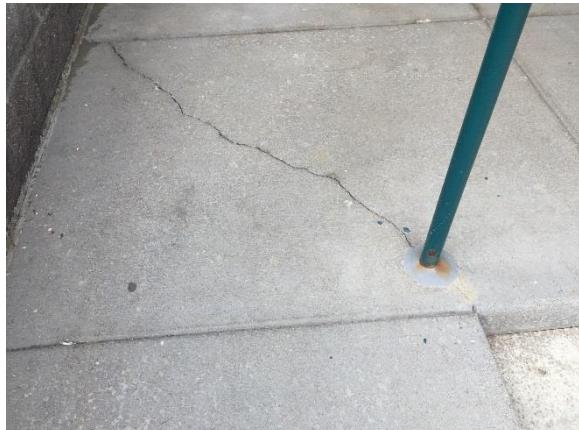
Figure 24. Cracked sidewalk slab on north side of building

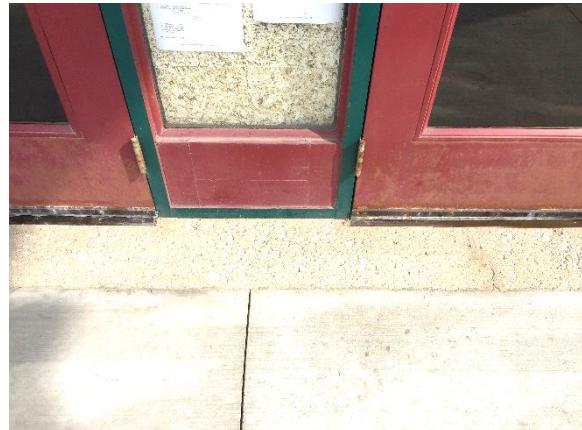
Figure 25. Corrosion and rust staining visible at base of main entry doors

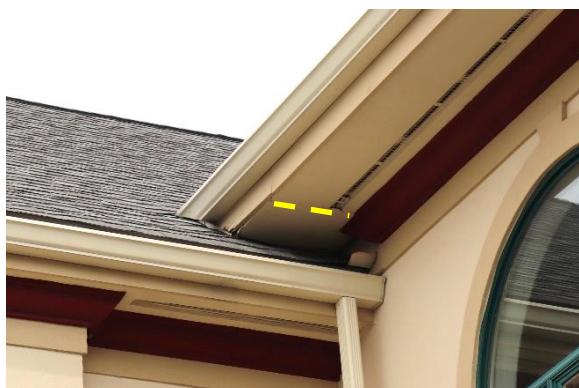
Figure 26. Crack in EIFS soffit

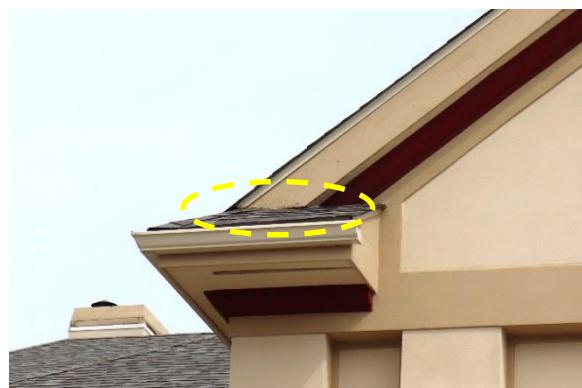
Figure 27. Deterioration of fascia where it meets roofing plane

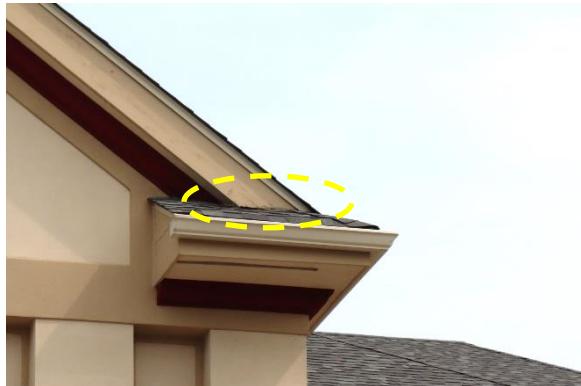
Figure 28. Deterioration of fascia where it meets roofing plane

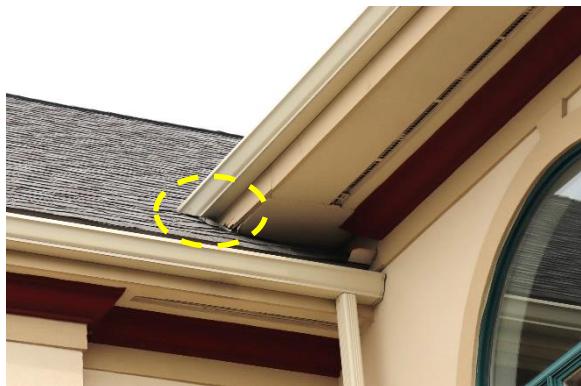
Figure 30. Water damage of fascia at roofing plane

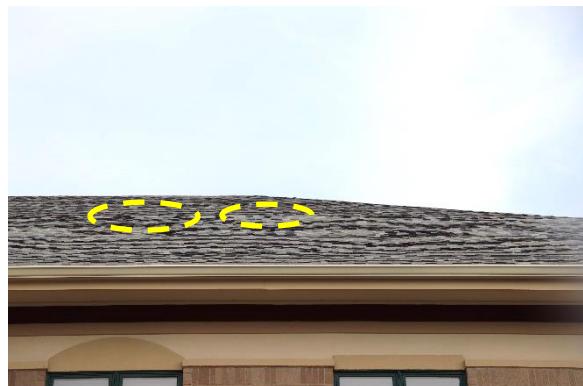
Figure 31. Raised shingles on south face at east gable

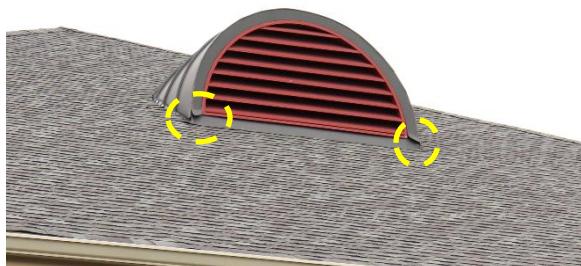
Figure 32. Damage to vent frame

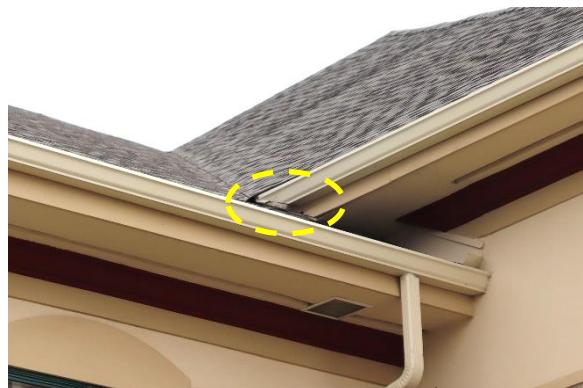
Figure 33. Deterioration of fascia where it meets roofing plane

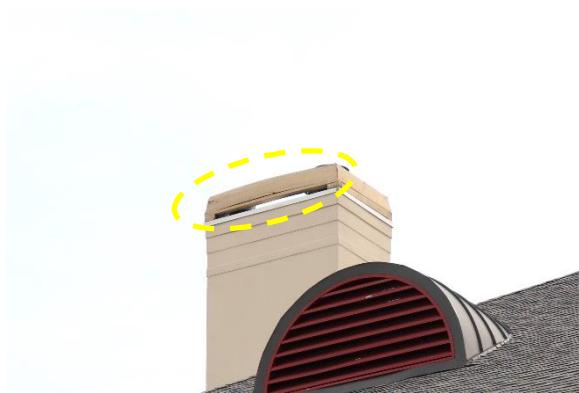
Figure 34. Deterioration of wood on chimney

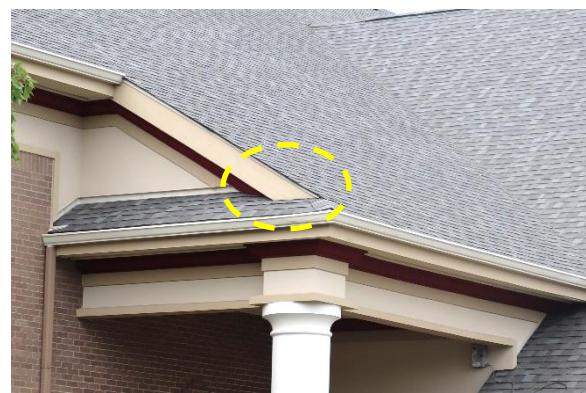
Figure 35. Deterioration of fascia where it meets roofing plane

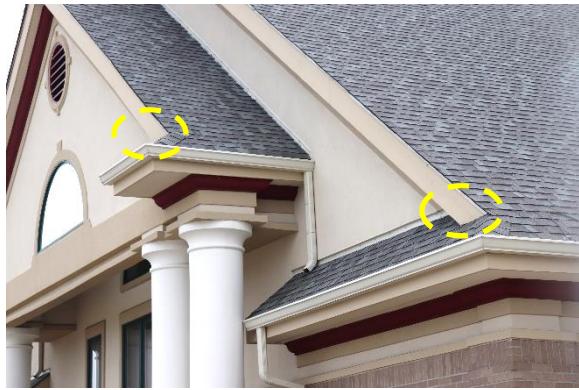
Figure 36. Deterioration of fascia where it meets roofing plane

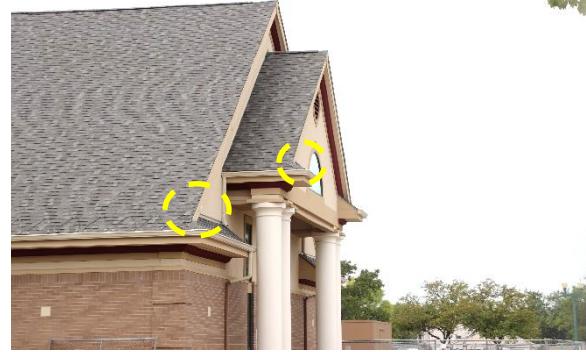
Figure 37. Deterioration of fascia where it meets roofing plane

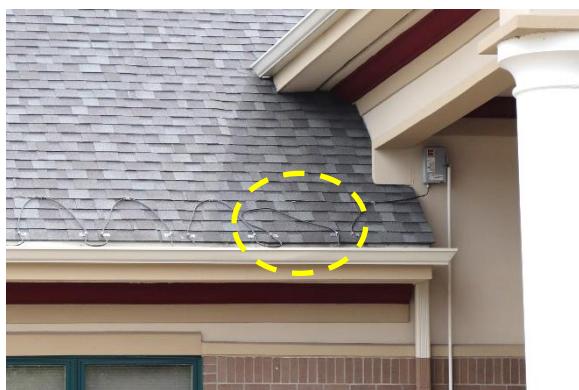
Figure 38. De-icing cable detached from clip

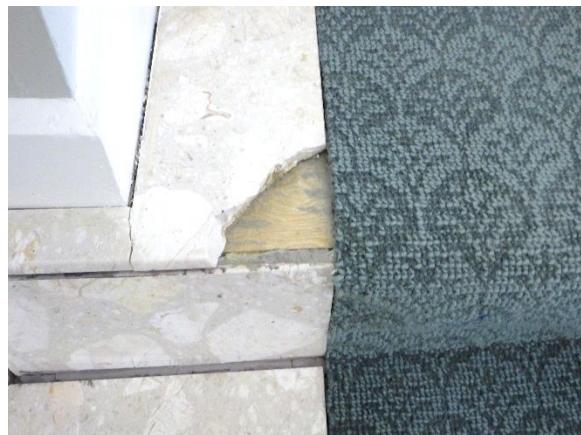
Figure 43. Broken floor tile at entry stairs

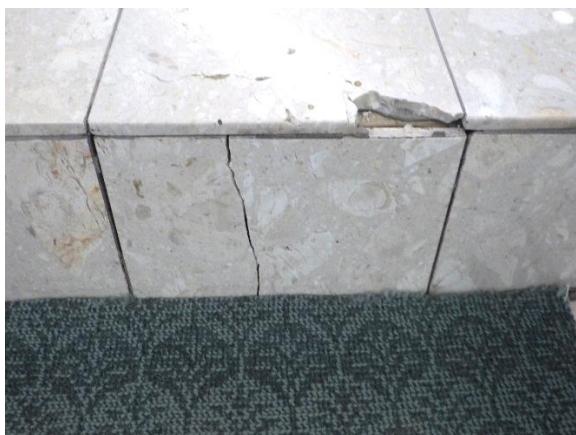
Figure 44. Cracked and broken floor tile at entry stairs

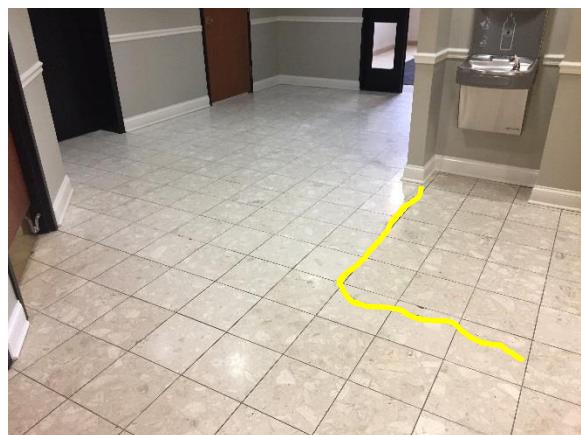
Figure 45. View of cracked ceramic floor tile

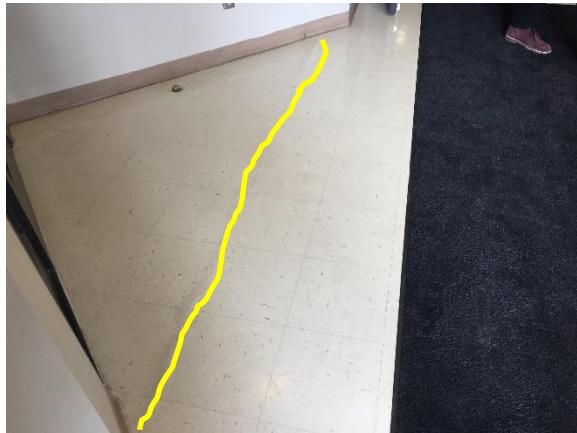
Figure 46. View of cracked vinyl floor tiles

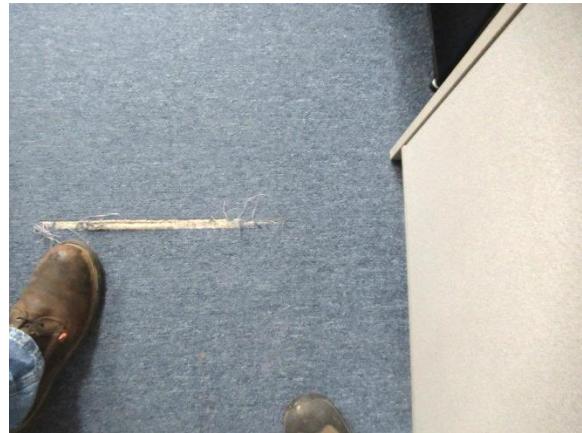
Figure 47. View of torn or ripped carpet

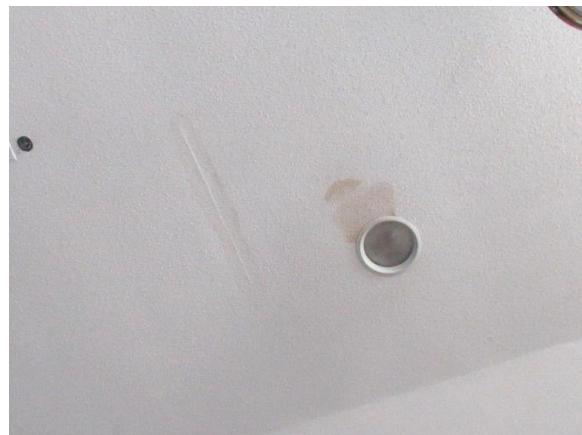
Figure 49. View of water staining on the ceiling

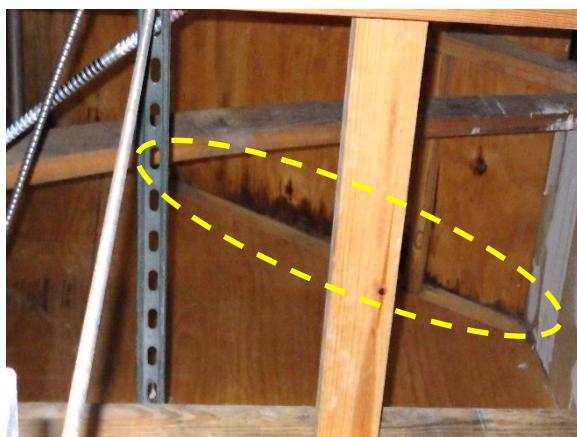
Figure 50. View of water staining on the plywood roof sheathing

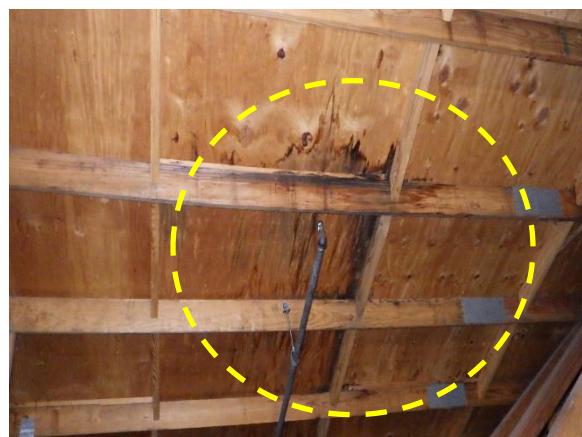
Figure 51. View of deteriorated plywood roof sheathing and 2x framing

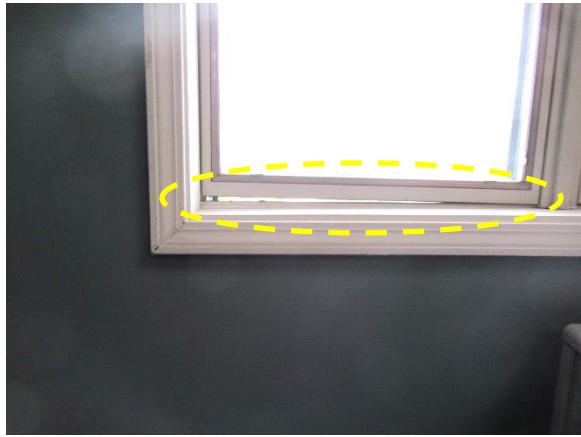
Figure 52. View of window that does not properly close

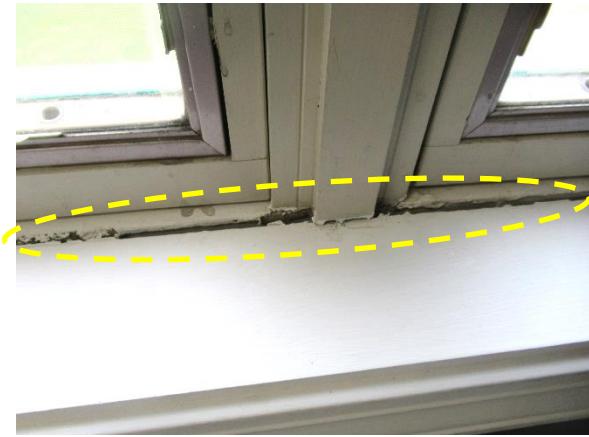
Figure 53. View of sealant failure and separation at window sill
