City Hall

Supplemental Condition Assessment

FINAL REPORT – REVISION 1

April 1, 2021
WJE No. 2021.1687

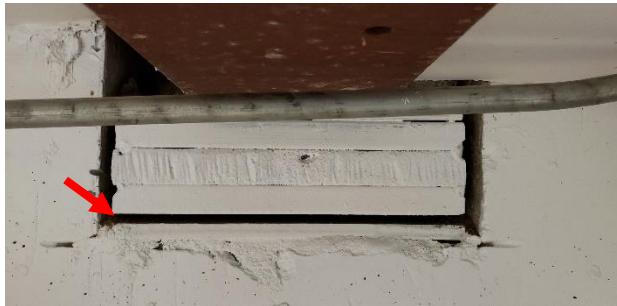
- Along the east wall of the basement, a steel wide-flange beam ("I-beam") was raised 0.3 inches above the bearing surface of the pocket (Figure 14).
- Hairline, vertical cracking existed on the west wall of the concrete basement near a wall penetration for a mechanical duct (Figure 15).

Figure 14. Steel wide-flange beam with gap between the bearing surface of the pocket

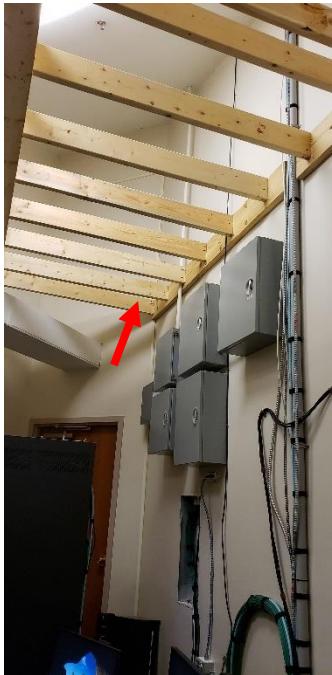
- Horizontal wood framing was installed in the audio-visual room (A-V Room) at the northwest corner of the Auditorium. This framing, braced the wall between the two rooms (Figure 22). The City had the bracing installed to stabilize the wall to accommodate installation of large televisions on the wall in the Auditorium.

Figure 22. Wood bracing in A-V room at the northwest corner of the Auditorium to support televisions hung from the walls

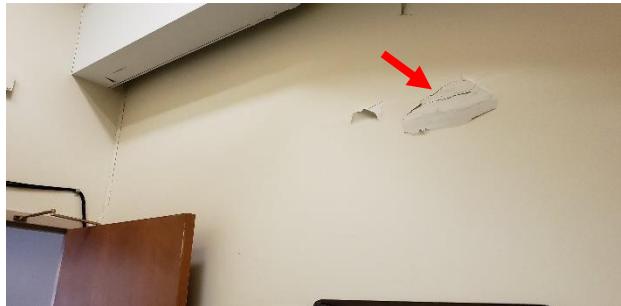
- Along the west face of the A-V Room of the Auditorium, the gypsum sheathing finish had tearing at the southwest room corner and some buckling near mid-length (Figure 23).

Figure 23. Tearing of gypsum sheathing finish in A-V room of the Auditorium

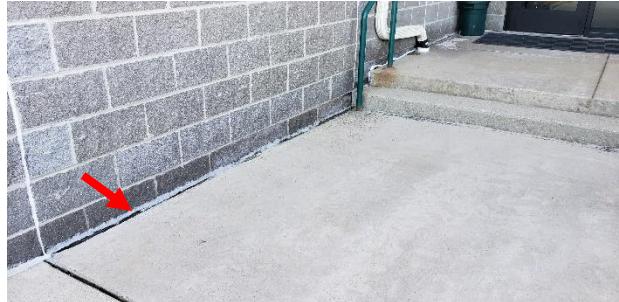
Figure 32. Approximately 1 inch of vertical displacement of the concrete flatwork at auditorium exterior wall

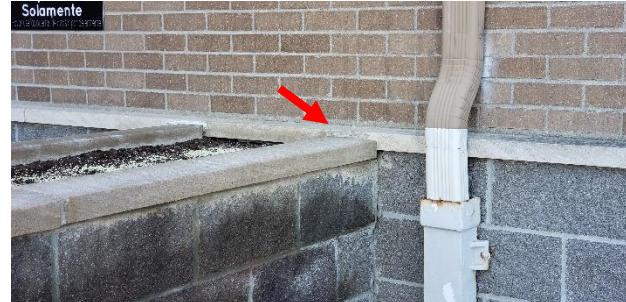
Figure 33. Approximately $\frac{3}{4}$ -inch of vertical displacement of the planter adjacent to the north exterior building wall

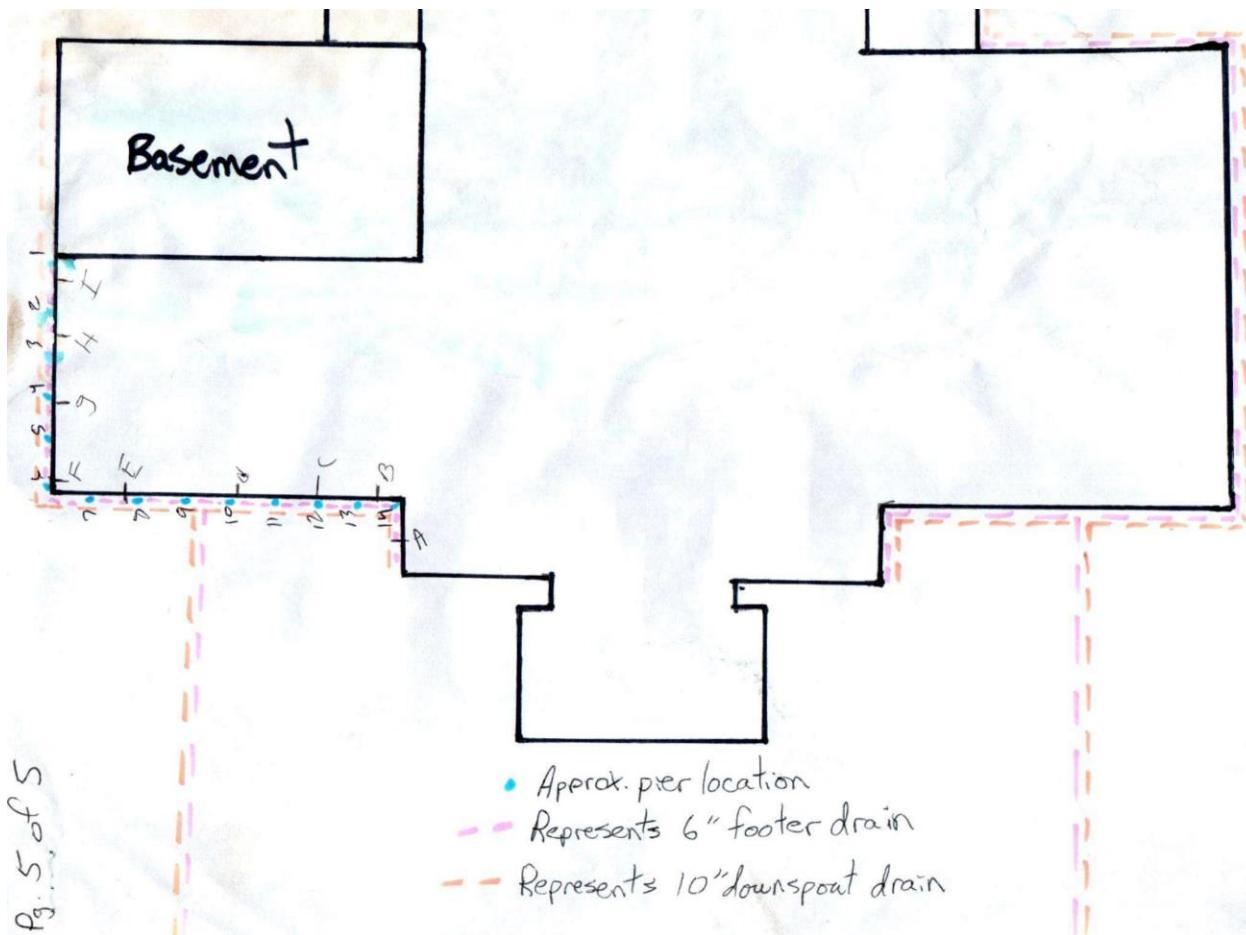
Cardno ATC's report also stated additional helical piers were installed "within the last year,"⁶ which corresponds to late 2012 or early 2013. Acculevel's March 20, 2012 Proposal/Contract included a scope to install 14 helical piers comprising "non coated P35H material to be installed to approximately 35-feet below the footer." Refer to Figure 34 showing a sketch of the purported locations (numbered and shown with a blue dot) provided by Acculevel.

Figure 34. Excerpt from plan sketch showing approximate helical pier installation locations installed in 2012

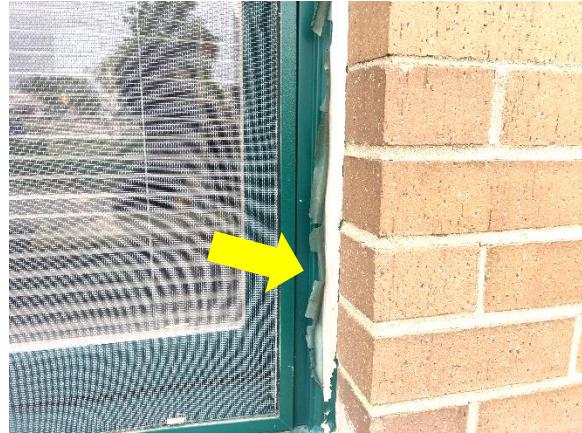
- There is crazing of sealant in the CMU wall expansion joint (Figure 22).
- Chipped and flaking paint exists at window frame perimeter joints (Figure 23).

Figure 23. Flaking paint on window frame

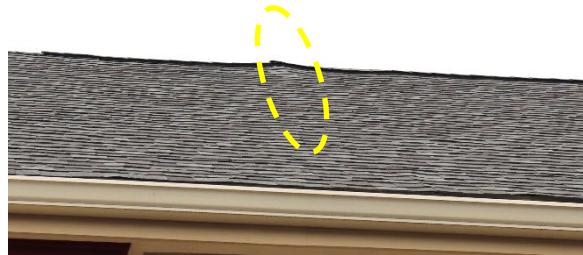
- There are raised shingles on the south face of the west gable (Figure 29).
- Water damage of fascia board was observed on the south gable roof (Figure 30). This location was along the south edge on the central southeast hip at west end where it meets the east face of the south gable roof.

Figure 29. Raised shingles on south face at west gable

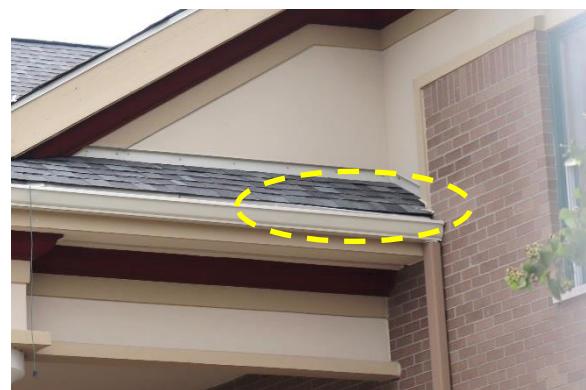
Figure 39. Edge metal and edge of shingles appear out of plane with roof edge.

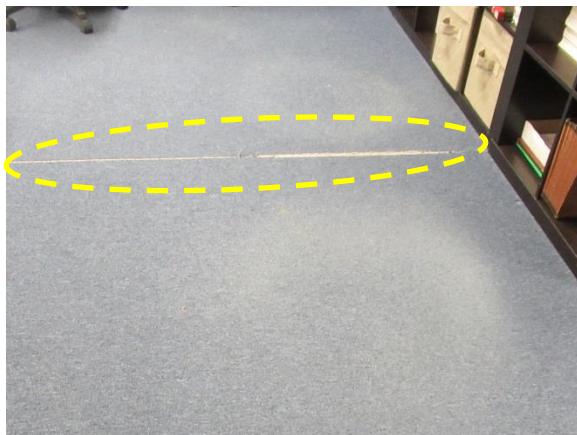
Figure 48. View of torn or ripped carpet

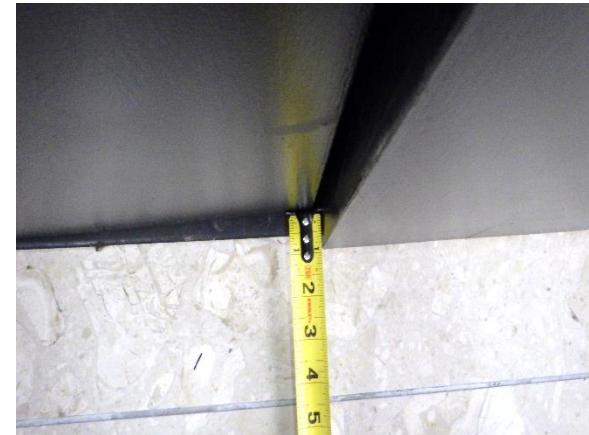
Figure 55. View of misalignment of doors in the closed position at the auditorium

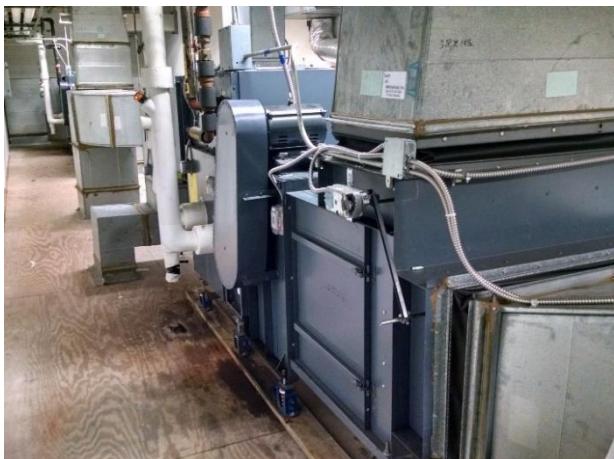
Typical of Three (3) Air Handlers

1. All air handlers and distribution ductwork should be replaced. Building needs to be evaluated for proper zoning and air capacity. Dehumidification capability should be incorporated into air handlers and controls.
2. Men's and Women's toilet rooms should be upgraded for ADA compliance and new water-saving fixtures installed.
3. Replace all exhaust fans for toilet rooms.
4. Interior and exterior lighting fixtures should be replaced with efficient LED lighting. Lighting controls need to be added for energy savings.
5. Building electrical power and distribution system should be upgraded. Increase service capacity and add distribution panels.
6. Emergency generator should be replaced and relocated with upgrade of building power system.
7. Domestic water softener should be replaced.

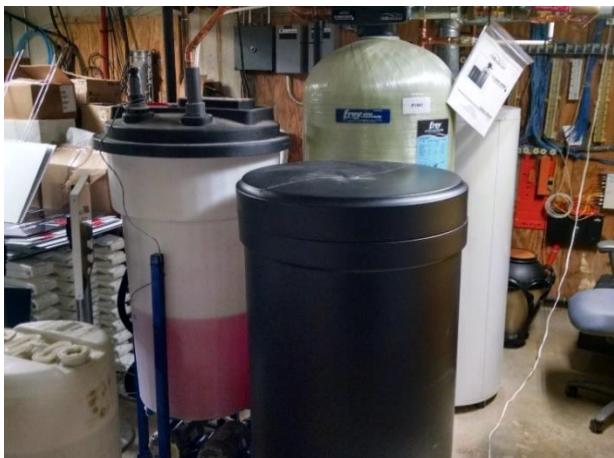
Domestic Water Softener

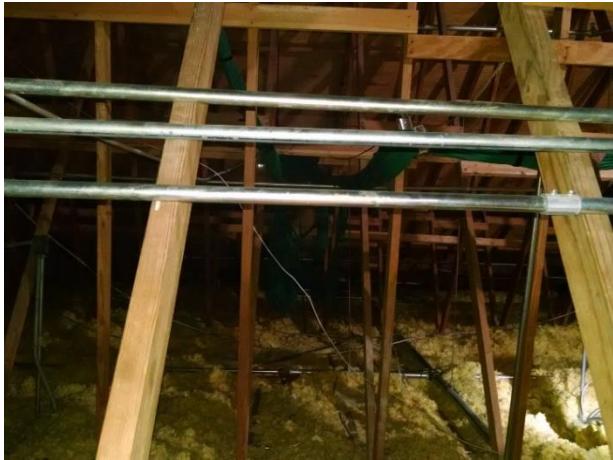
Typical Attic Area Needs Added Insulation.

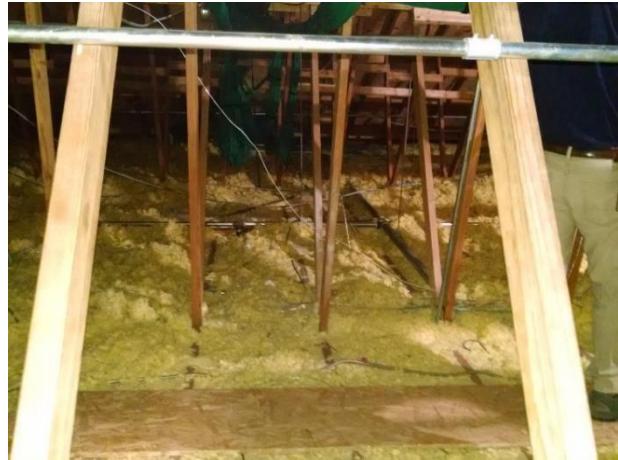
Typical Attic Area Needs Added Insulation.
